Inspection Report
Minerals Regulatory Program
Report Date: March 31, 2005

Mine Name: Unpermitted

Permit number: M/035/024

Inspection Date: March 15, 2005

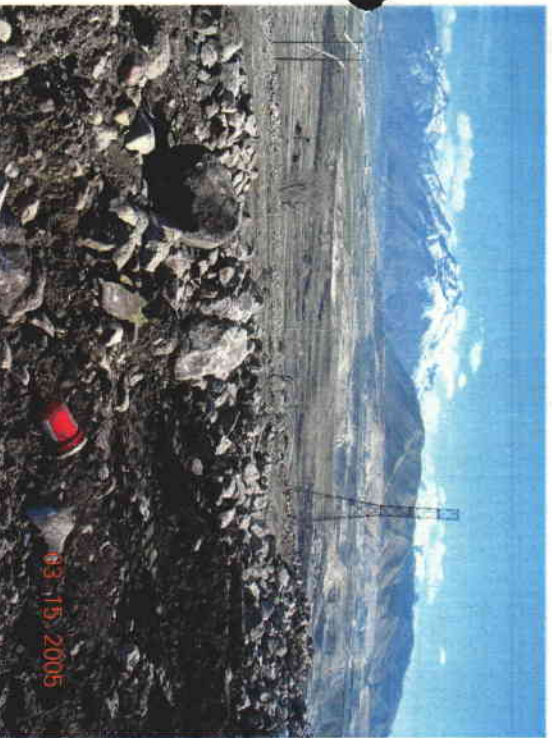
The trackhoe was digging in a hole about 5-10 feet deep and was excavating large rocks which are used in the operator's landscaping business (Photo 1). Other disturbances in the area are shown in Photos 2-4. These disturbances are basically on the surface and do not include excavations. Much (though not all) of the vegetation has been removed in these areas, and there are a lot of rocks on the surface. The soil has been disturbed and may have been mixed with subsoil materials. I think it unlikely that the soil has been damaged much, but this is possible.

Photo 2. View of some of the disturbance in the area.

1. Because there is so much disturbance in the area, and because it is impossible to distinguish between the areas for which the operator is and is not responsible, the area included in the NOI needs to be marked with T-posts or something similar.

2. Any reclamation required by the Stop Work Conference needs to be done ***as quickly as possible***. The normal time to reclaim is in the fall; seeding in the spring can work if done early enough and if there is consistent adequate precipitation.
